U.S. Route 1 in Caroline County Existing Conditions Summary

FR-23-07 UPC123255 June 26, 2024

U.S. Route 1 in Caroline County Potential Alternatives

FR-23-07

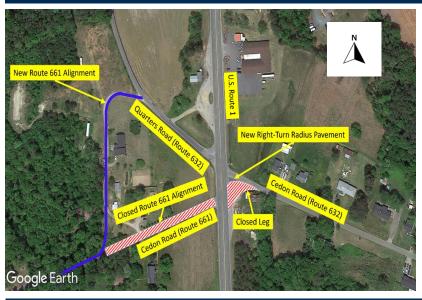
U.S. Route 1 at Quarters Road/Cedon Road

Lane Configuration Changes

- Realign Quarters and Cedon Road to remove the through movement skew
- Acquire and upgrade private road between Quarters and Cedon Road
- Connect new road from Cedon Road to Quarters Road and close the southeast leg of Cedon (traffic from Cedon Road will be diverted to Quarters Road)
- Close the southeast leg of Cedon Road
- Increase northbound right lane turn radius **Proposed Alternative Benefits**
- Reduce Driver Confusion and improve safety
