Project Overview | CU-23-07

US Route 17 Business from Frost Ave to Falmouth St (US Route 211; US Route 15)

Project Fact Sheet

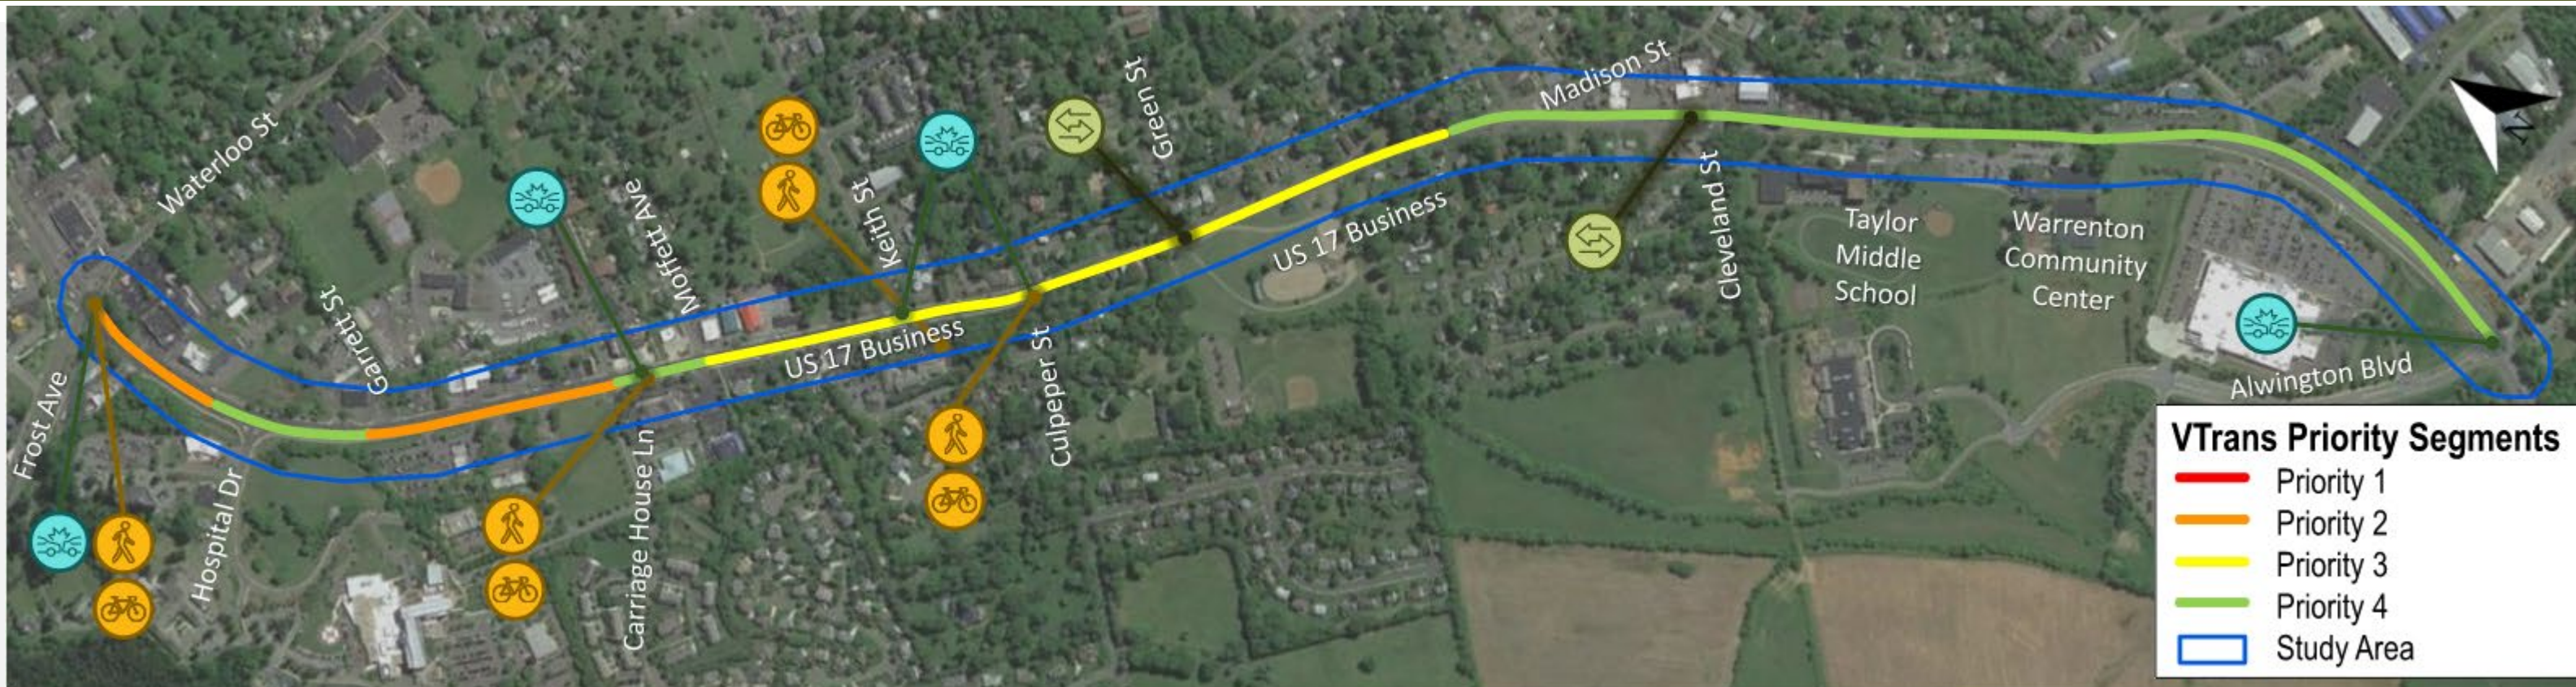
VTrans Priority Segments

- Priority 1
- Priority 2
- Priority 3
- Priority 4
- Study Area

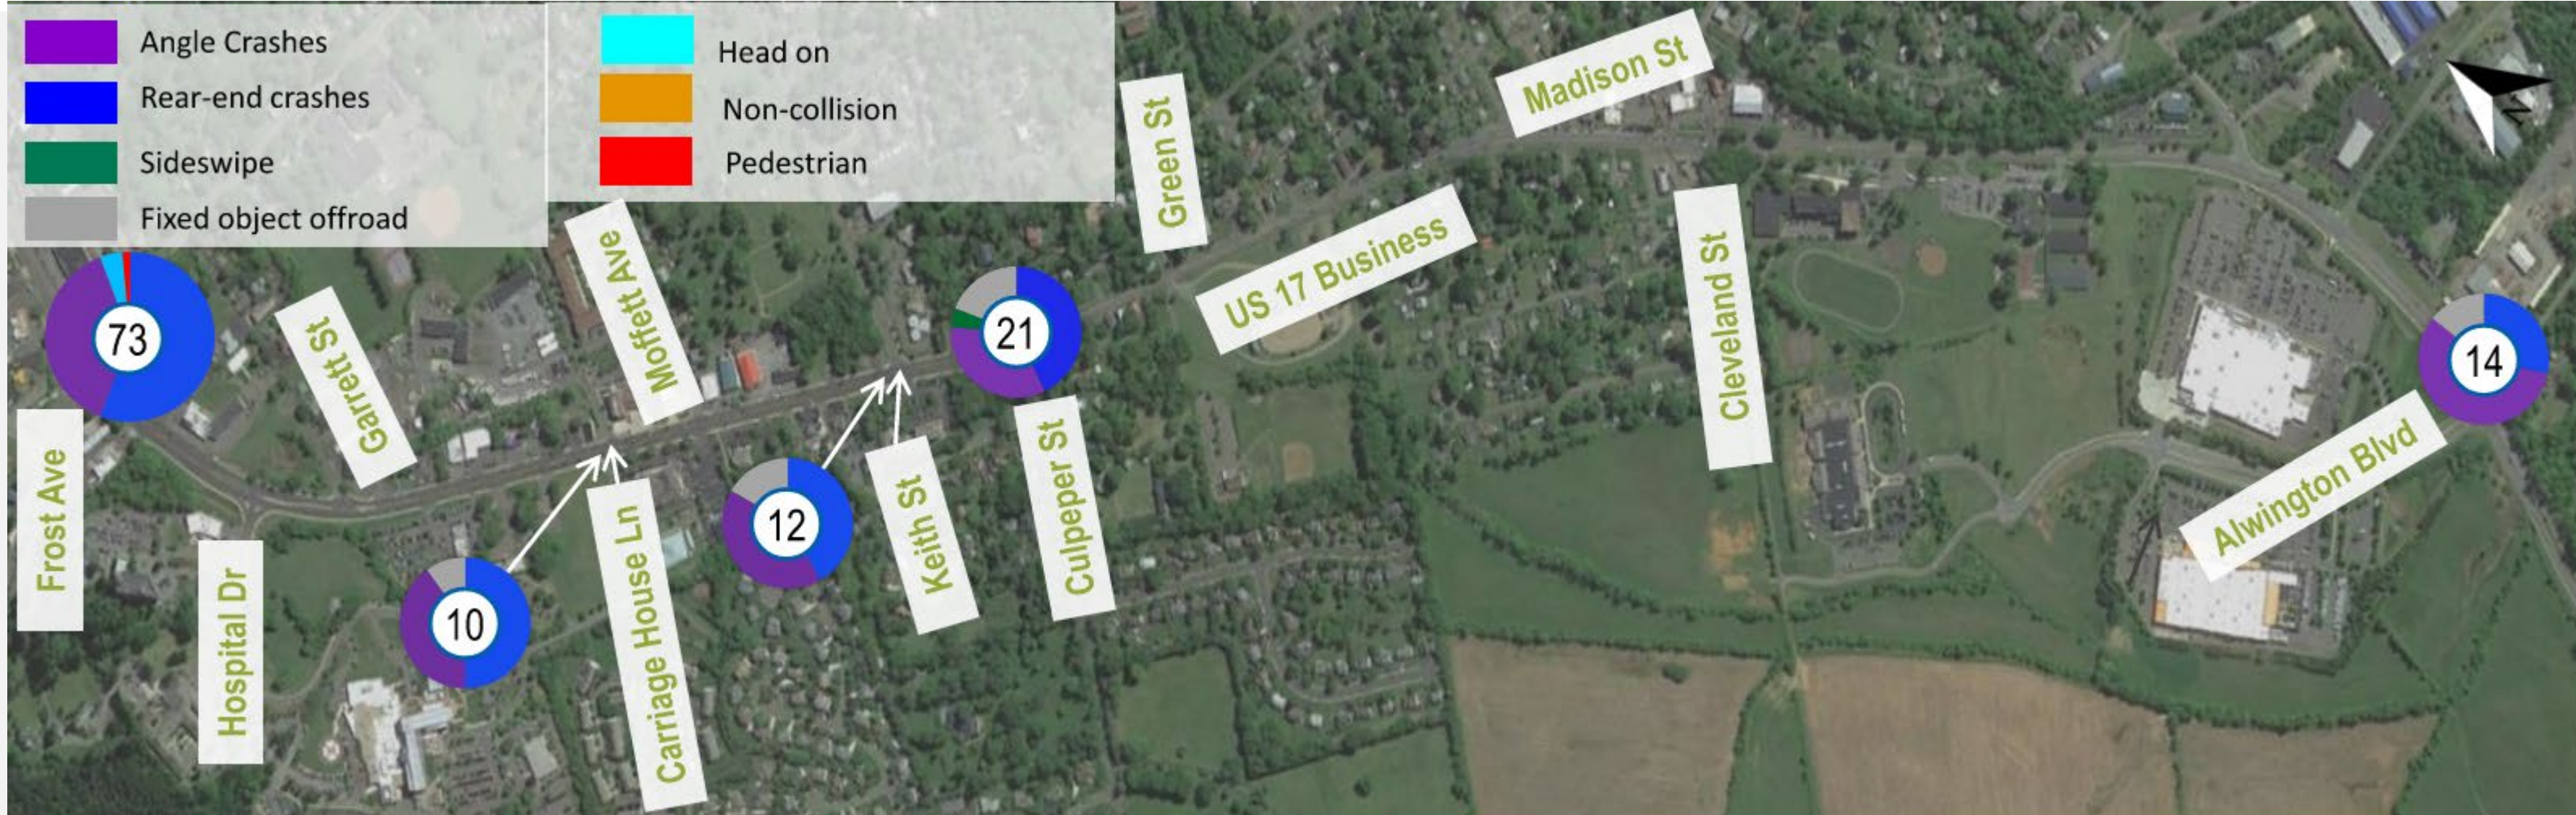
Needs Identification Summary

- 60% Property Damage Only
- 28% Nonvisible Injury
- 7% Visible Injury
- 4% Severe Injury
- 1% Fatality

198 crashes were reported in the study area, of which one hundred and sixty-four (164) crashes (83%) occurred at or within 150 feet of an intersection. A significant cause for crashes within the study area during the 5-year period was distracted driving (23%) of the overall.

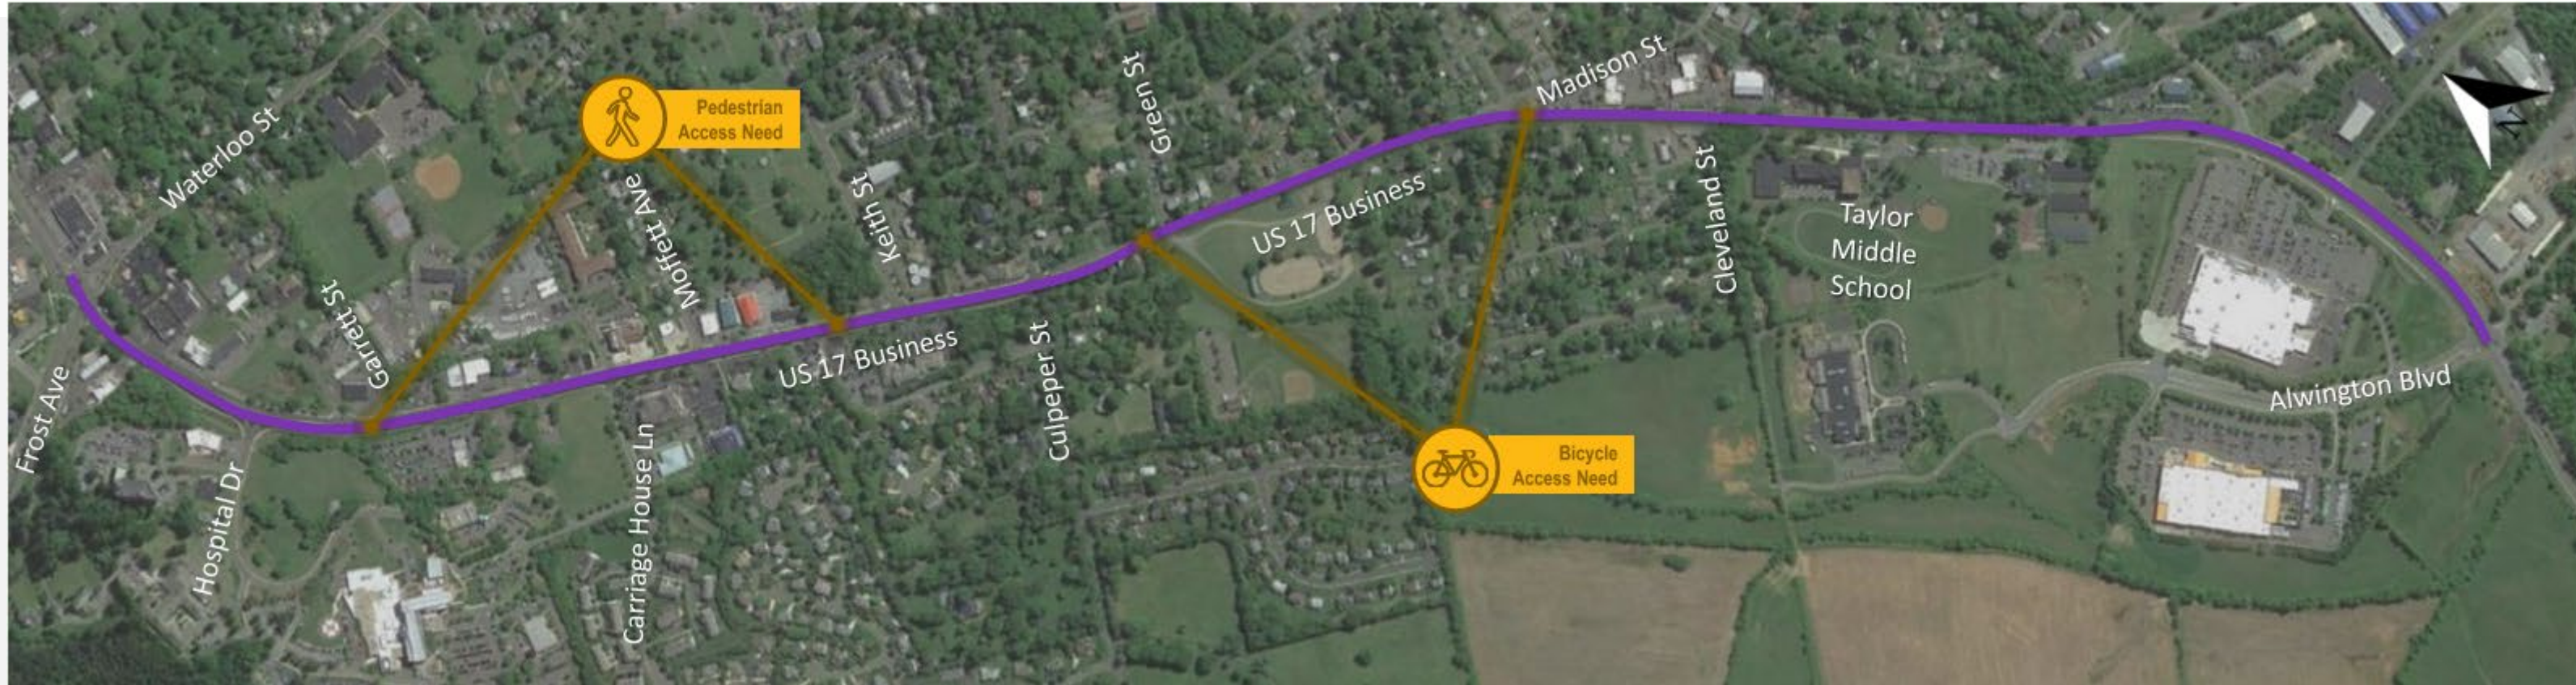
Bicycle and Pedestrian Safety and Accessibility Needs Identification Summary

Bicycle and Pedestrian Safety & Accessibility Summary

- VTrans identifies this corridor as VERY HIGH NEED for Congestion Mitigation, Transit Access for Equity Emphasis Areas and HIGH NEED for Bicycle Access Safety, and TDM. Pedestrian Access classified as MEDIUM NEED.
- 2 pedestrian crashes
- Sidewalks
 - Exist on both sides between Frost Ave and Culpeper St
 - Crosswalks – sufficient markings with curb ramps
 - Ped signals - with push buttons and countdown heads at the intersections
- Bikes
 - No SUP facilities along the corridor only.
 - Warrenton Branch Greenway is located east of the study corridor.

Legend

- Bicycle Access Need
- Pedestrian Access Need
- Activity Center
- Pedestrian Safety Need
- Potential for Bike Lane SUP, or sidewalk

- Fill in sidewalk gaps on the south/north side of Route 17 BUS
- Consider a SUP instead of on-road bicycle facilities
- Ped facility upgrades at majority of the intersections, including ADA ramps, high-visibility crosswalks, Hybrid Beacons, RRFBs and APS push button .
- Potential for future ped/bike connections to adjacent land uses and/or ped/bike oriented facilities.

Sidewalk exists along both sides of Route 17 BUS from Frost Ave to Culpepper St, and on the north side north side between Warrenton Community Center entrance to Alwington Blvd. Crosswalks have adequate markings with curb ramps. Ped signals – with push buttons and countdown heads noticed at Culpepper St and Frost Ave intersections.
