# PROJECT PIPELINE

CAROLINE COUNTY  
U.S. ROUTE 1 (FR-23-07) FROM SOUTHERN  
COUNTY LINE WITH HANOVER COUNTY TO  
NORTHERN COUNTY LINE WITH SPOTSYLVANIA  
COUNTY

# U.S. Route 1 (FR-23-07) From Southern County Line with Hanover County to Northern County Line with Spotsylvania County

Draft Report

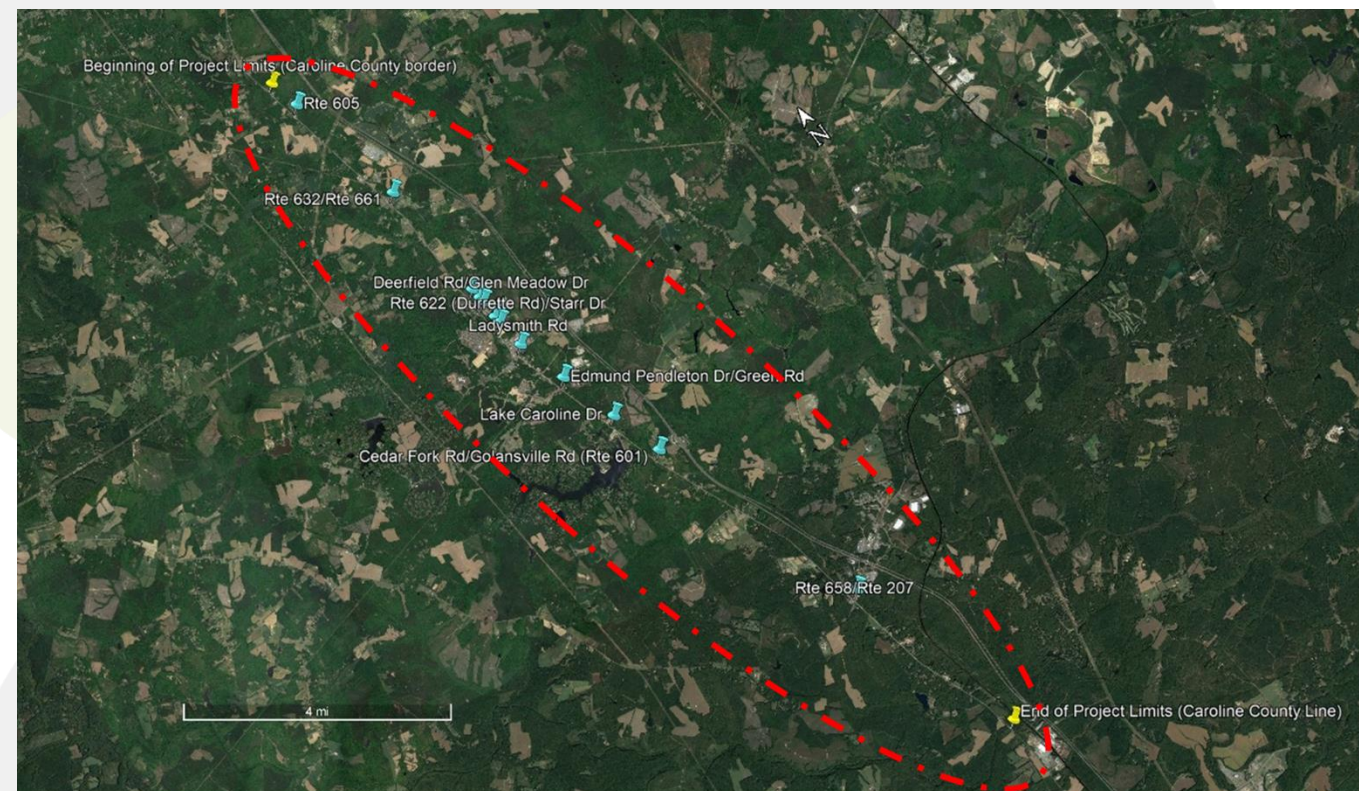
Figure 4: U.S. Route 1 Study Area Map

The study corridor is U.S. Route 1 (Jefferson Davis Drive) from the Southern County Line with Hanover County to the Northern County Line with Spotsylvania County. The study limit is 14.87 miles, and it runs in the north-south direction. According to the VDOT's functional classification map, U.S. Route 1 is an *Other Principal Arterial*. The speed limit along the corridor ranges from 45 miles per hour (MPH) to 55 MPH. During the stakeholder meetings, 12 intersections were identified to be analyzed along the corridor. A map detailing the locations of the study intersections along U.S. Route 1 is shown in **Figure 4**.

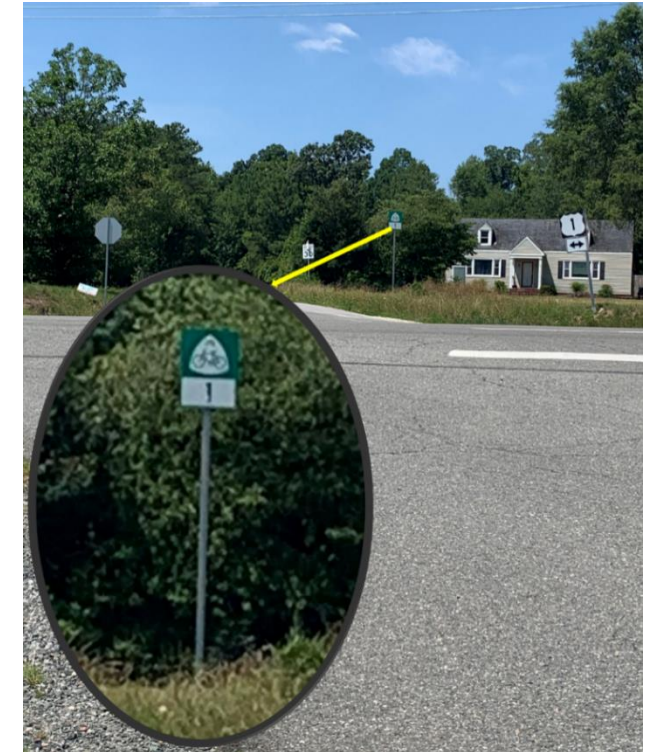
Figure 5: Cedon Road Bike Route Sign (Photo captured July 2023)

No bike activities were observed along the study corridor. U.S. Route 1 has no bike accommodations along the corridor. According to the East Coast Greenway mapping tool, U.S. Route 1, between Caroline County/Hanover County line and Jericho Road/Roger Clark Boulevard, and between Telegraph Road and Cedar Fork Road/Golansville Road, is a shared on-road bike route. However, no bike route signs were observed along U.S. Route 1 during the field review. There is a bike route sign along Cedon Road. The sign is shown in **Figure 5**. The bike route on Cedon Road is not indicated in the East Coast Greenway mapping tool, as shown in **Figure 6**. The U.S. Route 1 corridor is not a bus route; therefore, transit stops were not observed along U.S. Route 1. In addition, the Carmel Church Park-n-Ride lot was observed during the field visit. Only one vehicle was parked for the entirety of the field visit.

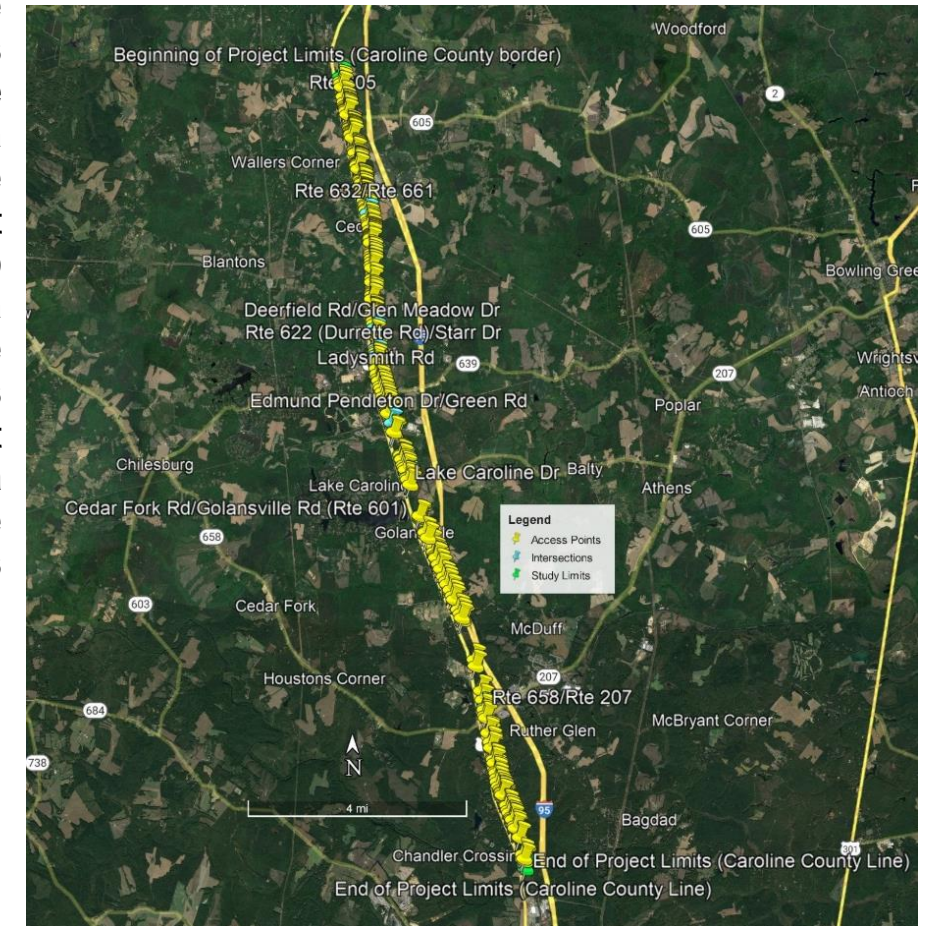
Figure 7: Access Point along U.S. Route 1

Most of the crashes that occurred near an access point were either angle or rear end crashes. Of the 134 angle crashes and 63 rear end crashes that occurred along the study corridor, 17 angle crashes and 22 rear end crashes were located at access points that are not part of an intersection. While most of these crashes were scattered throughout the access points along the corridor, there was one location that had a significantly higher rate of crashes. Seven angle crashes occurred in Hotspot 3 from the crash analysis, the entrance of a shopping center north of the intersection of U.S. Route 1 at Ladysmith Road. This appears to be the only access point that has a strong correlation between the number of crashes and access management issues. While it is not fully known if access spacing is a result of these crashes, it should be noted that at most of the access points where a crash occurred, there was no designated turn lane, or two-way left-turn lane median.

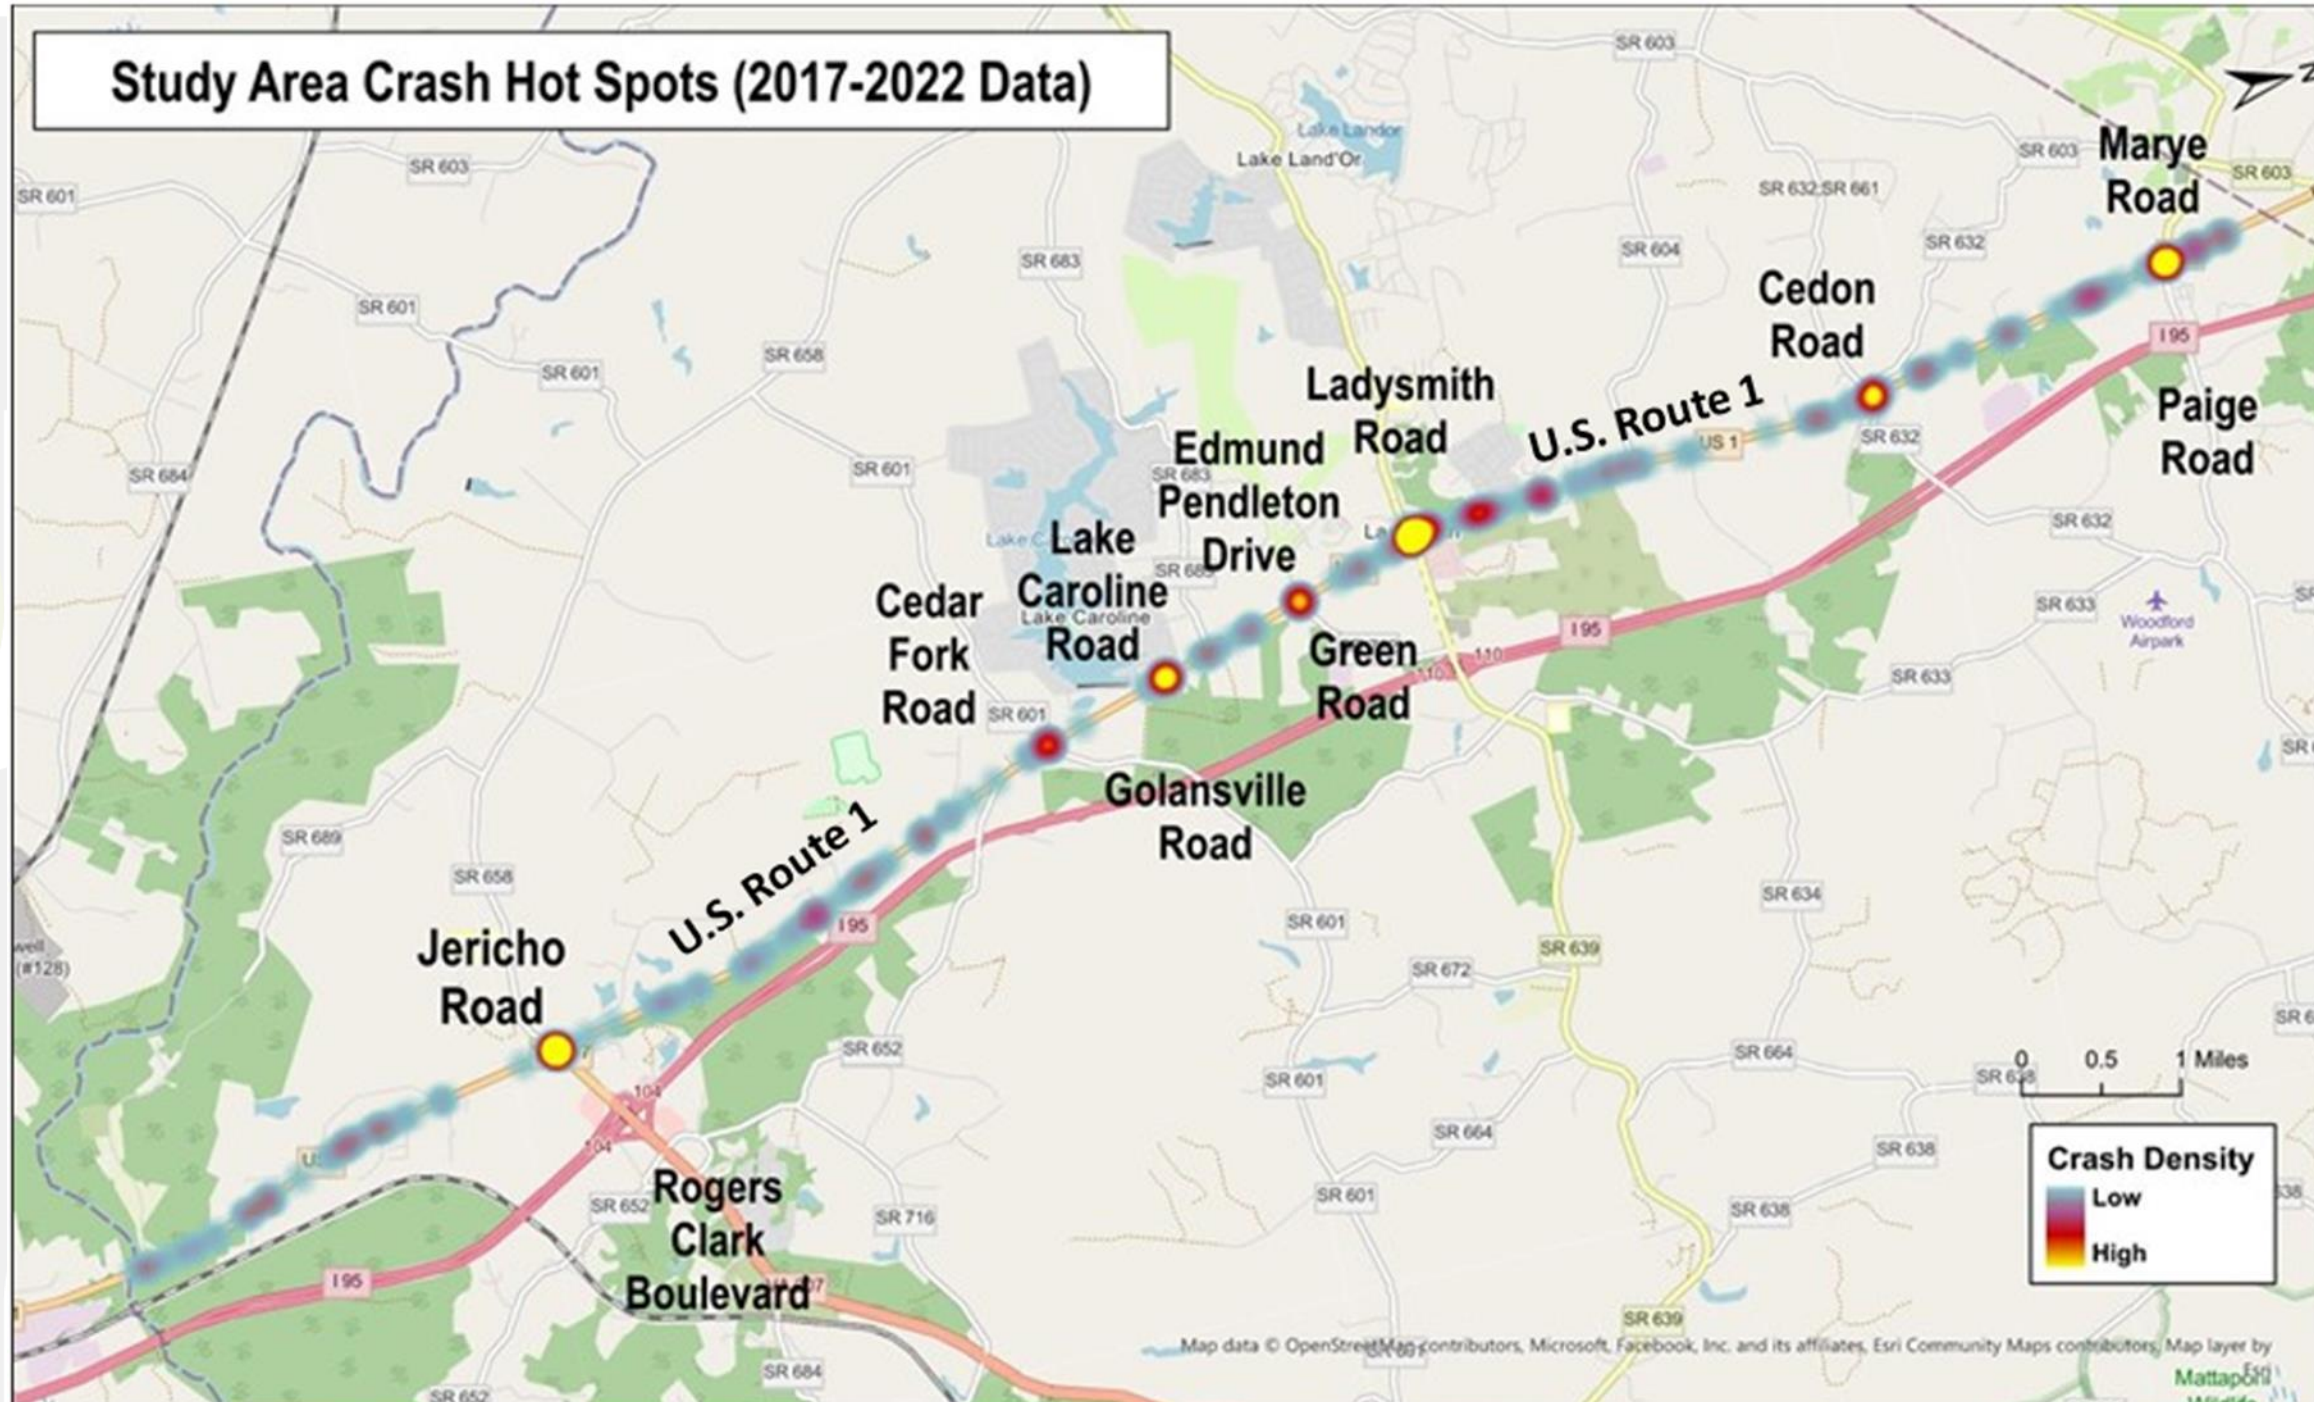
Figure 14: U.S. Route 1 Corridor Crash Frequency Heatmap

In addition, the crash rate per mile was determined to be 3.74 crashes per mile. Four hotspot locations along the corridor were observed. The hotspot locations were determined based on occurrence of five or more crashes within a 250-foot radius. The hotspot locations do not include intersection crashes. Intersection crashes are described in the following section.

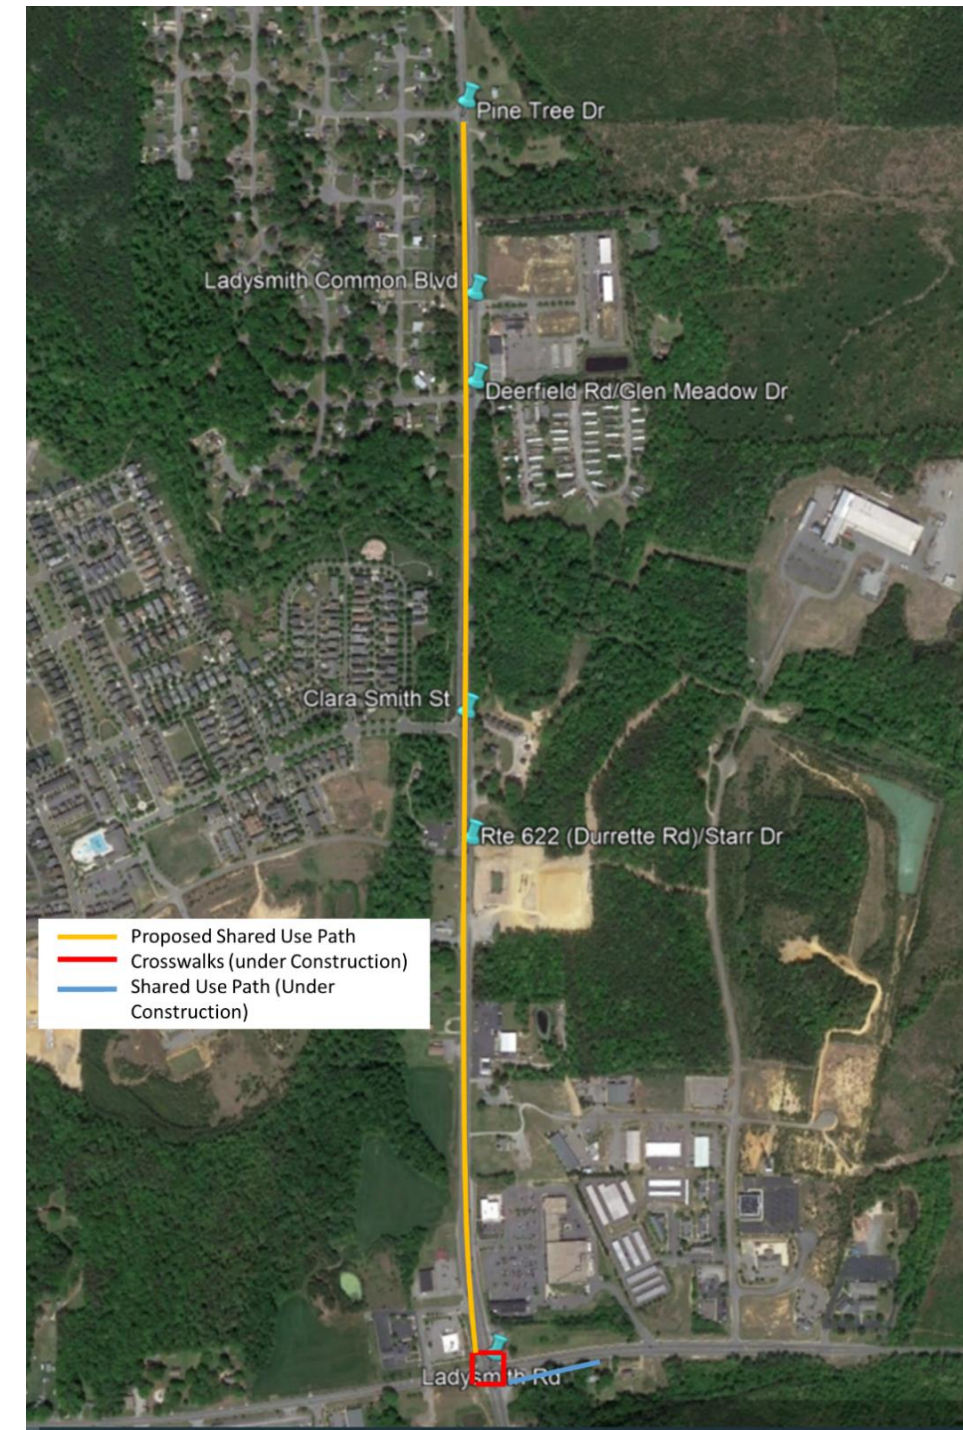
Figure 15: Proposed Pedestrian Improvements

It is recommended to add a shared use path for both pedestrians and cyclists along the U.S. Route 1 corridor starting at Pine Tree Drive and continuing south to the intersection of U.S. Route 1 at Ladysmith Road, as shown in **Figure 15**. With the current construction on Ladysmith Road, crosswalks will be added to all four approaches of the intersection. A 10-foot shared-use path will also be installed on the south side, and a 5-foot sidewalk will be installed on the north side along Ladysmith Road from 0.15 mile west of U.S. Route 1 to 0.84 mile east of U.S. Route 1. According to VTrans, Pedestrian Access and Bicycle Access are a high priority while Pedestrian Safety is a very high priority. These improvements will help address the VTrans needs.

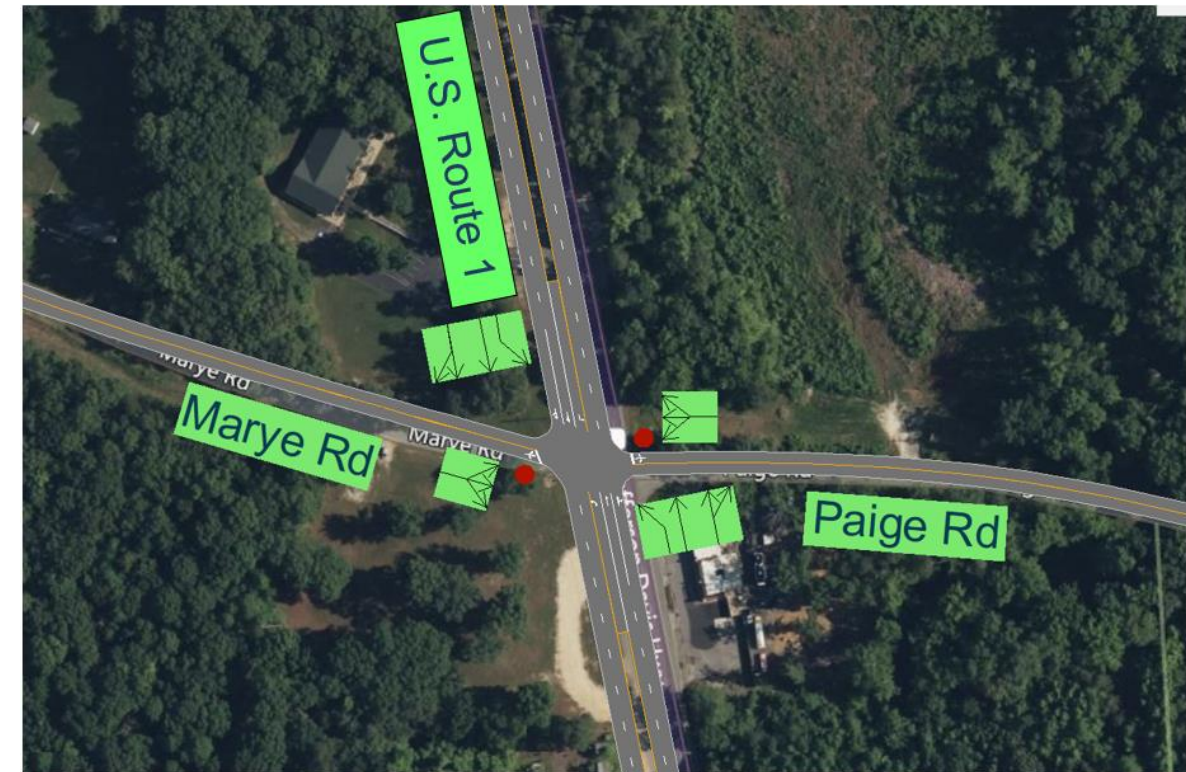
Figure 16: U.S. Route 1 at Marye Road/Paige Road Improvements

This unsignalized intersection is operating at an LOS A in the AM and PM. However, this intersection does have 25 crashes in the study period, 14 of which are angle crashes. Accordingly, a designated southbound left-turn lane is recommended to provide vehicles more time to turn. Also, the southbound left-turn existing volume warrants a left-turn lane. In addition to installing the southbound left-turn lane, installing a northbound left-turn lane is recommended. This is presented in **Figure 16**. Furthermore, the northbound right turning radius was recommended to be improved to be in compliance with the VDOT's geometry standards.

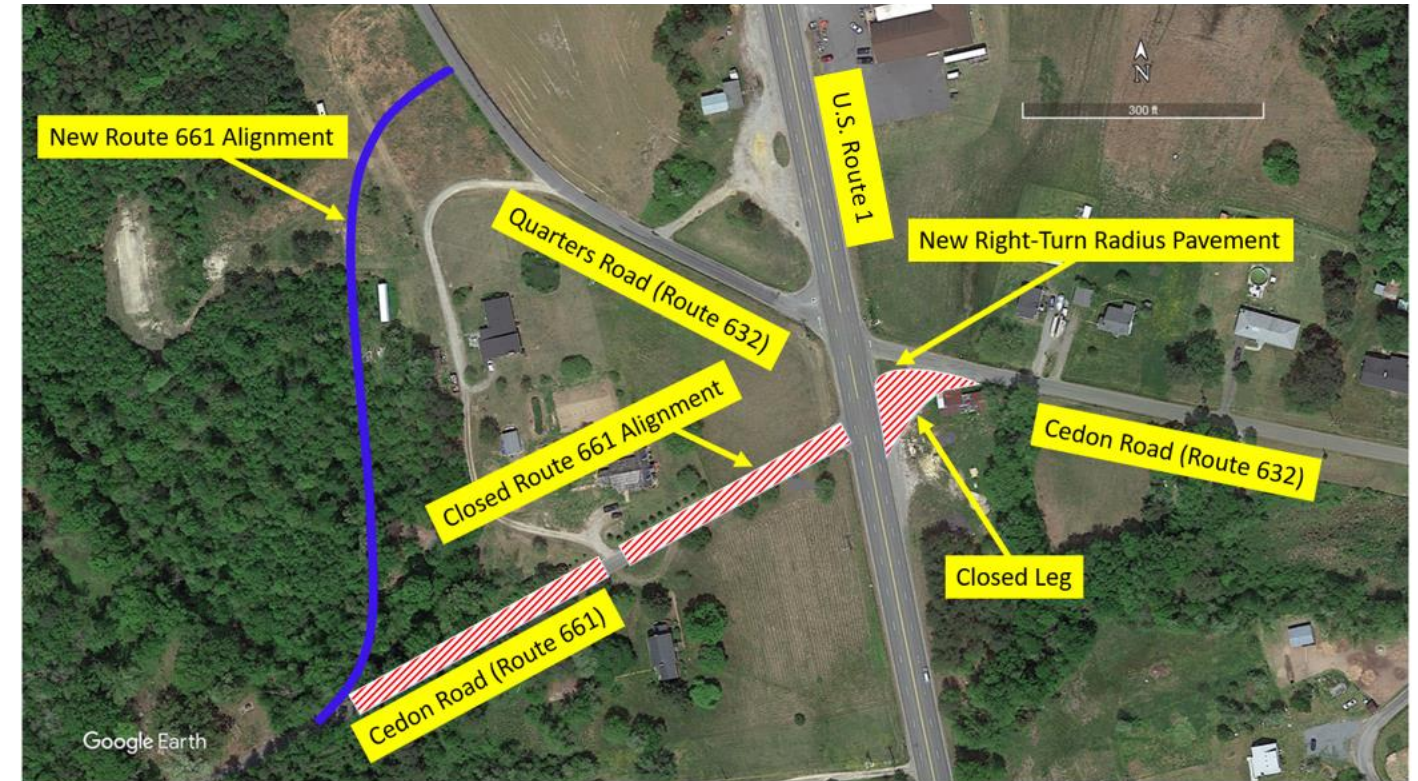
Figure 17: U.S. Route 1 at Quarters Road/Cedon Road High-Cost Improvements

- All the traffic from Cedon Road (Route 661) to U.S. Route 1 will be diverted to Quarters Road (Route 632).
  - Close the southeast leg of Route 632 facing Cedon Road (Route 661).  
Increase the northbound right-turn radius for adequate right-turn radius at the northeast leg of Cedon Road (Route 632).

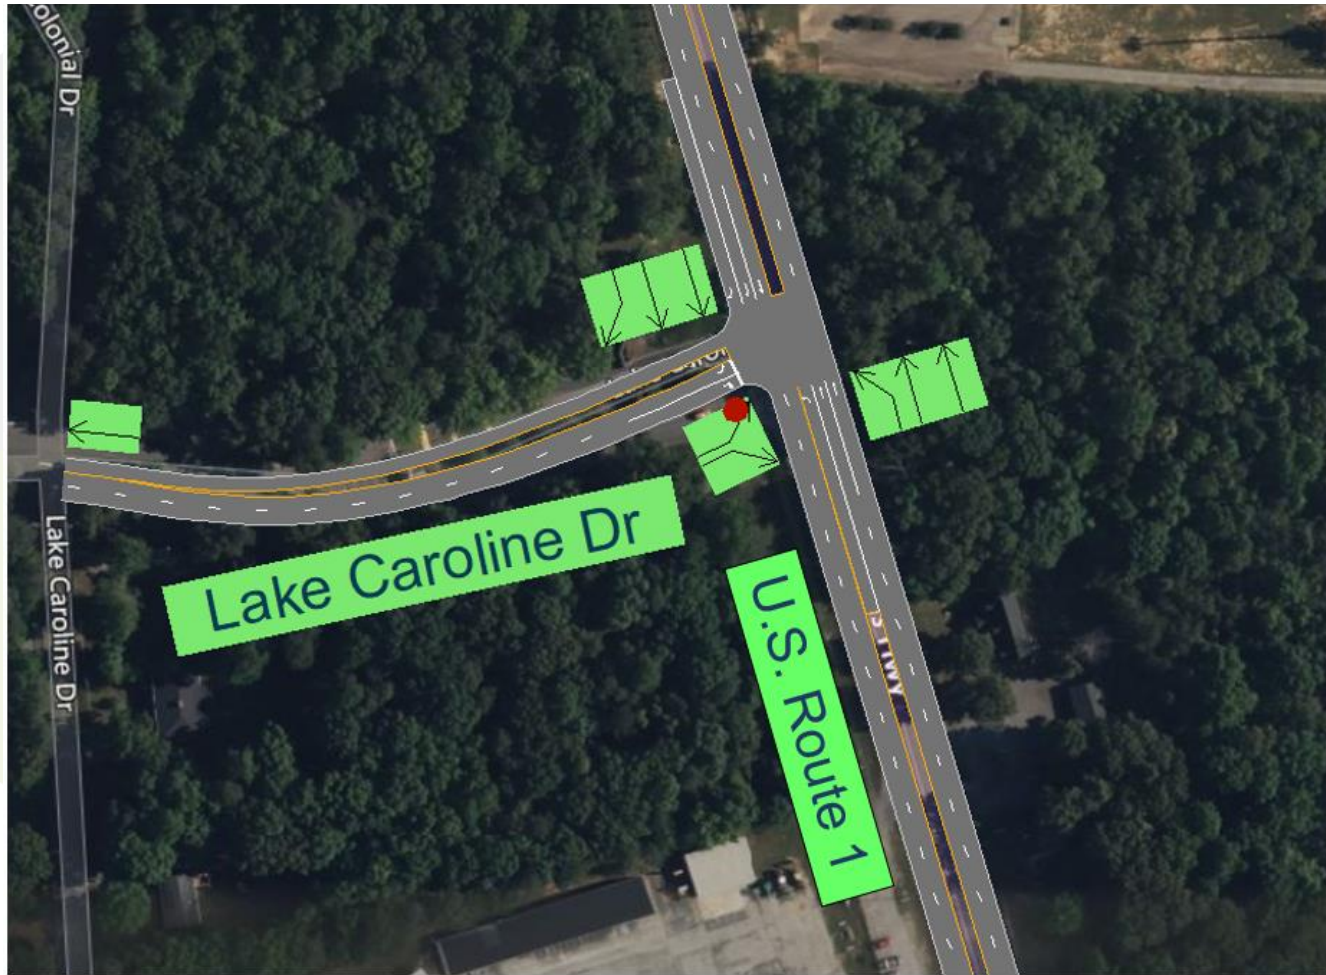
Figure 18: U.S. Route 1 at Lake Caroline Drive Improvements

U.S. Route 1 at Caroline Drive was an intersection mentioned in the public survey as an area with lack of turn lanes into the side street. There are large numbers of right turning vehicles from the southbound direction (174 vehicles per hour (vph) in the PM peak hour) and northbound left turning vehicles (87 vph in the PM peak hour), which currently do not have designated turn lanes. This could create a safety and operational issue, accordingly, an exclusive southbound right-turn lane and exclusive northbound left-turn lane is recommended at the intersection, as shown in **Figure 18**. Likewise, stripe the eastbound lane to separate the left-turn and right-turn movements, the existing lane (lane width is approximately 25 feet) can accommodate both lanes. This will allow vehicles to have their own lane to turn right onto U.S. Route 1 South, instead of waiting for a left-turning vehicle.

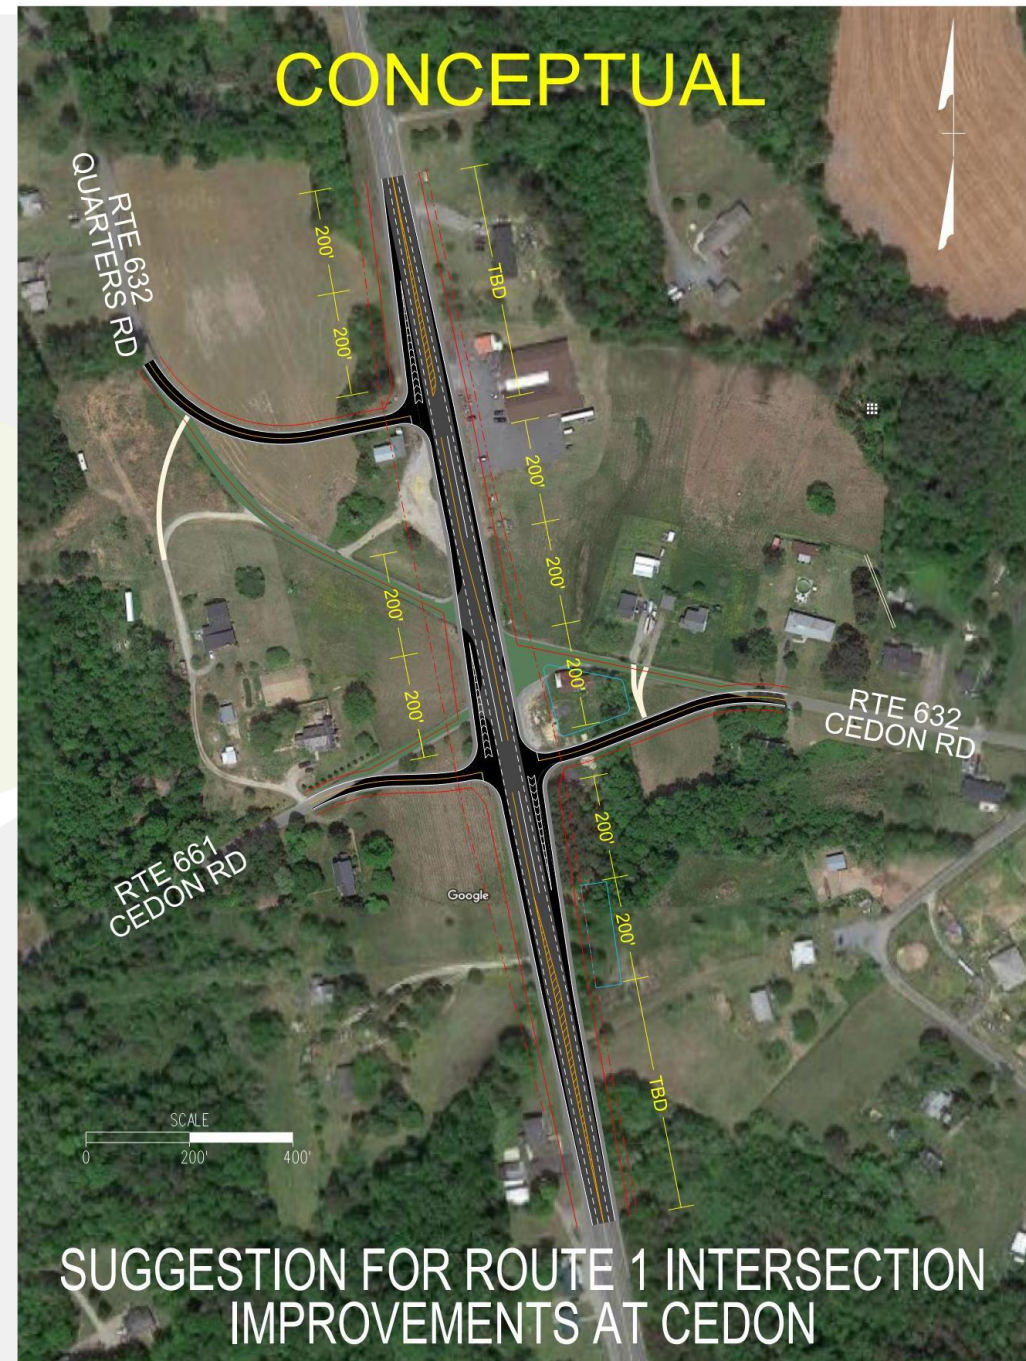
Figure 41: U.S. Route 1 at Cedon Rd./Quarters Rd.

Through meetings with stakeholders, it was determined that this alternative will not move forward to Phase 3. VDOT, however, provided an updated concept image that shows the anticipated improvements that may be studied in future applications. The revised concept can be seen in **Figure 41**.
