# PROJECT PIPELINE NEEDS AND EXISTING CONDITIONS SUMMARY

US 58 and US 15 – Clarksville Bypass

VDOT District: Richmond District / Locality: Town of Clarksville/ Mecklenburg County

RI-25-03

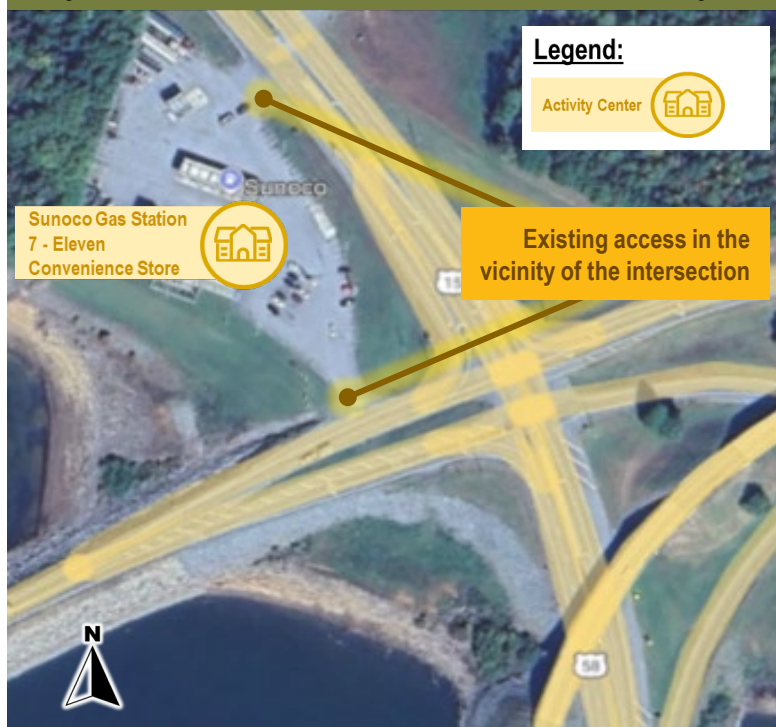
## Bicycle/Pedestrian Access Needs Identification Summary

- No existing crosswalks or sidewalks present at the study intersection.
- No fatal crashes involving a pedestrian between 2020-2024.
- The **Pedestrian Access VTrans** Need is based on “*Applicable roadway segments within walking distance (one mile) of VTrans Activity Centers, fixed-guideway transit stations, or BRT lines.*”<sup>1</sup>

- No existing bicycle lanes / shared-use paths in the vicinity of the study site.
- No crashes involving a bicyclist between 2020-2024
- The **Bicycle Access VTrans** Need is based on “*Applicable roadway segments within biking distance (seven miles) of VTrans Activity Centers, fixed-guideway transit stations, or BRT lines.*”<sup>1</sup>

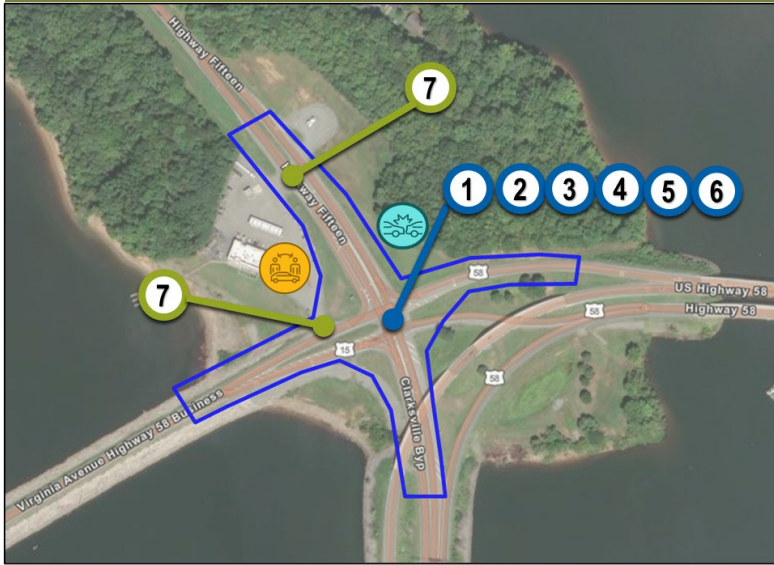
## Phase 1 Scoping-Level Improvement Concepts

- 1 Intersection Tightening
- 2 Signage and Pavement marking improvements
- 3 Raised medians / curb- extensions
- 4 Intersection Lighting improvements
- 5 Potential Median U-Turn
- 6 Potential Roundabout

- 7 Access point review and improvements at the 7-Eleven Gas Station

- 8 Park and Ride facility (other than the unofficial use of 7-Eleven Parking Lot) could be beneficial
