# **PROJECT PIPELINE**

**Route 218 (Caledon Road) from Bloomsbury Road  
to Lambs Creek Church Road**

**Fredericksburg District  
King George County  
FR-25-04**

**PHASE 3 REPORT  
July 2026**

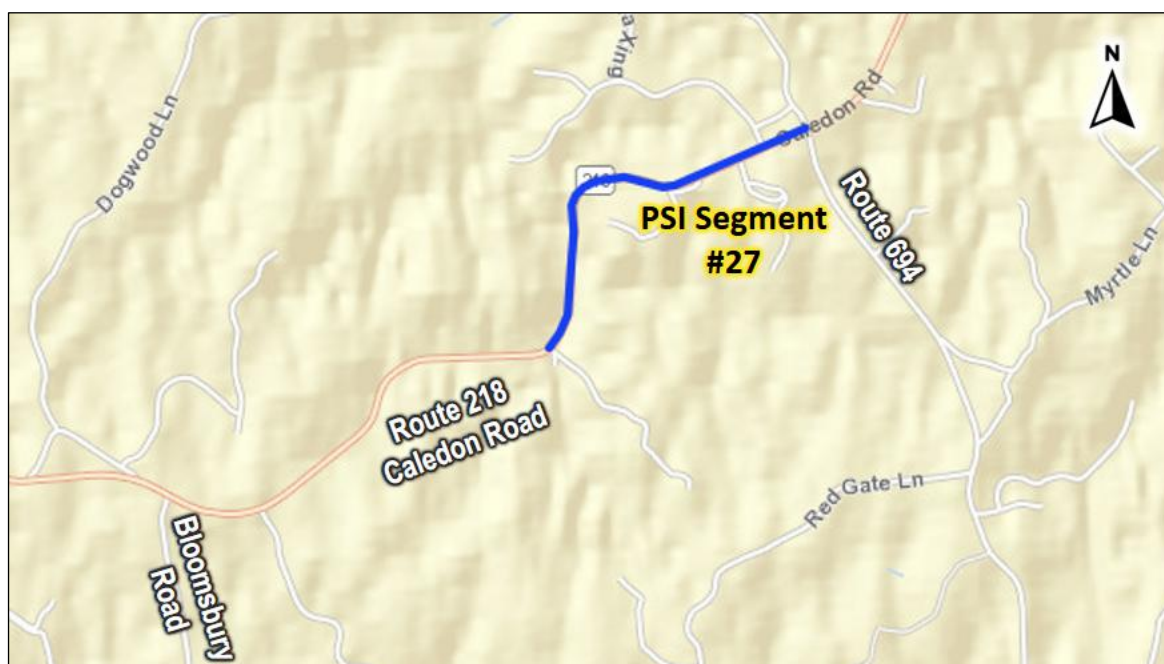
**Figure 8: PSI Segment Location**

Route 218 is not within the VDOT Pedestrian and Bicycle Safety Action Plan (PBSAP). Route 218 is ranked 27<sup>th</sup> in the VDOT Rank District 2019-2023 Potential Safety Improvement (PSI), shown in **Figure 8**. This PSI ranking reflects a crash rate (crashes per 100 million Vehicle Miles Traveled) of 654.21, which is significantly higher than the Fredericksburg District crash rate from 2019 to 2023 of 101.67 for rural Minor Arterials. The statewide crash rate for rural Minor Arterials from 2019 to 2023 was 127.99. This indicates a clear need for safety improvements in the study area. The study area did not include a Reliability VTrans need, which is measured by variability in travel time along a corridor and impacted by factors such as incidents, weather, construction, and changes in demand.

All intersection and roadway segments within the VDOT linear referencing system (LRS) are evaluated annually for the PSI based on the Highway Safety Manual (HSM) methodology by VDOT. The crash frequency, severity of crashes, volume, and length of segment are contributing factors in the predicative analysis. Crash predictions, based on the safety performance function (SPF) crash data files, are made for intersection and segments. The top 100 intersections and 100 miles of segments are published by VDOT for each district on an annual basis. Route 218 between Vertical Ridge Road and Lambs Creek Church Road was identified as one of the top 100 2019-2023 PSI segments, with a ranking of 27 within the VDOT District category. See previous **Figure 8**.

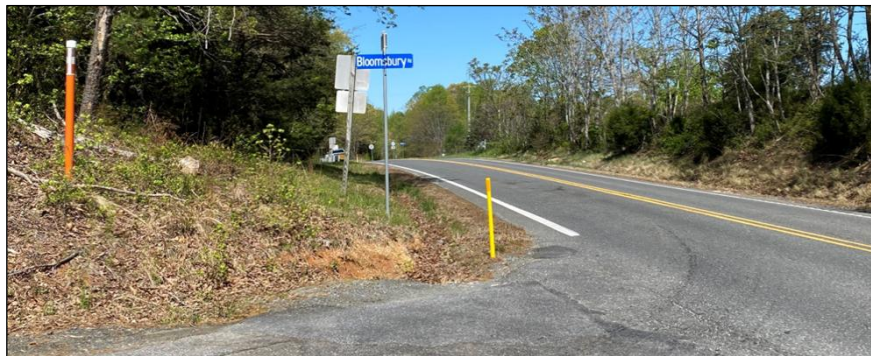
**Figure 11: Bloomsbury Road, looking west**

- There are significant sight distance concerns due to road curvature, especially the sight distance looking west from the Bloomsbury Road approach, shown in **Figure 11**.

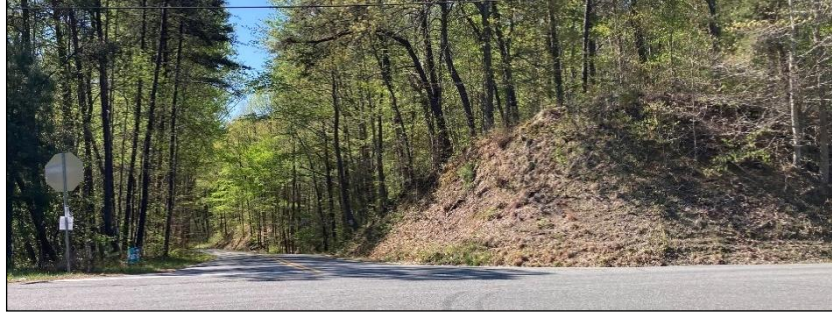
**Figure 12: Lambs Creek Church Road, looking south**

- Guardrail is needed on the north side of the curve on the east leg of the intersection.
- Significant sight distance concerns due to embankment when making a turn from the Lambs Creek Church Road approach.
- Pavement markings need to be refreshed.
- Inadequate sight distance looking to the east when exiting the Long Leaf Lane approach, shown in **Figure 12**.

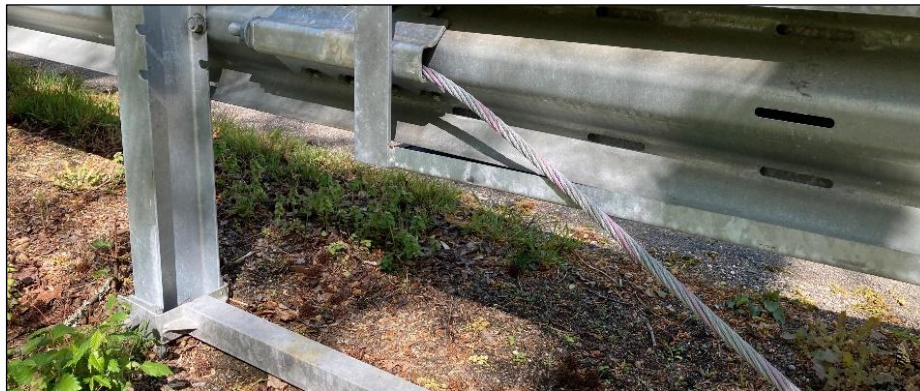
**Figure 13: Guardrail in the curves near Vertical Ridge Road**

- The westbound travel lane near Ford Lane has rumble strips, but the flashing beacon is hard to see during daylight.
- There is no stop sign and a faded stop bar marking at the intersection with Sierra Crossing.
- There are sight distance concerns for vehicles with driveways on Route 218, especially near the Vertical Ridge Road curves.
- Tight curves causing sight distance concerns for those travelling along the corridor.
- Vegetation trimming needed to improve visibility.
- Rumble strips effective for eastbound traffic but pavement markings need to be refreshed.
- Guardrail installation should be reviewed, as grade requirements are not met at end terminals. See **Figure 12.**
